AFAPL-TR-69-35
Volume III

ADVANCED TURBINE ENGINE GAS GENERATOR
CONCEPTUAL STUDIES AND FEASIBILITY
EXPERIMENTAL TEST PROGRAM
(UNCLASSIFIED TITLE)

Volume III: Materials Section (Table LXXV)

Frederick G. Groh
Pratt & Whitney Aircraft Division
United Aircraft Corporation

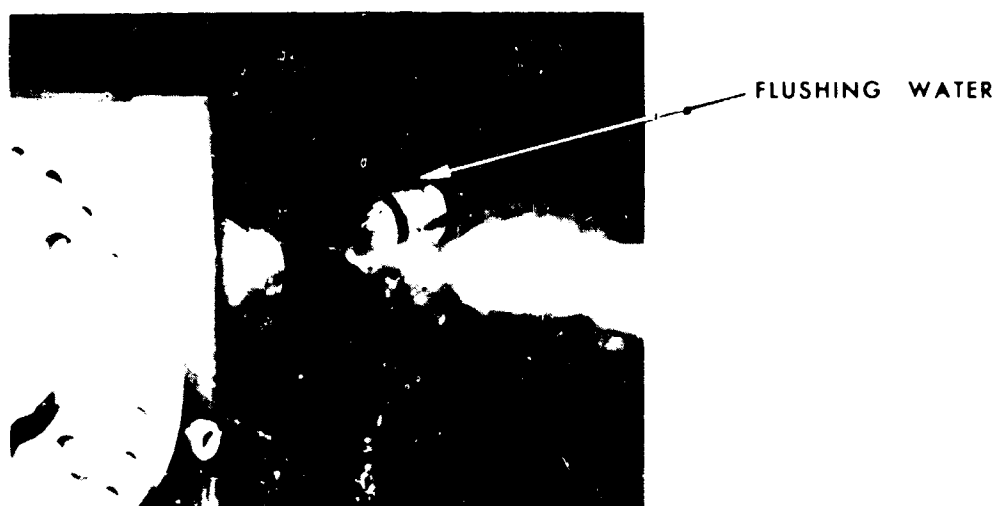
STREAM WITH POWER OFF

STREAM WITH POWER ON

Figure 10 Closeup View of Push-Pull Low-Cycle Fatigue Specimen Being Drilled by ECID Process

(U) The ECID (electrochemical impingement drilling) process is a special application of the electrochemical machining process. In the ECM process, the cathode tube carrying the electrolyte moves through the work piece, and, therefore, the smallest hole that can be produced is limited by the outside diameter of the cathode tube. In the ECID process, this limitation is eliminated by releasing the electrolyte through a jet across a gap of 0.020 to 0.100 inch. The jet is produced by pumping the electrolyte into the nozzle at high pressure. A direct-current power supply is placed across the electrolyte and the work piece, which deplates material from the work piece. A schematic diagram of the equipment used for the process is shown in Figure 7. Figure 8 shows the appearance of the equipment at the start of the program, and Figure 9 shows the appearance of the equipment after modifications were made to permit three-dimensional positioning of the nozzle. A closeup view of a typical specimen being drilled is shown in Figure 10.

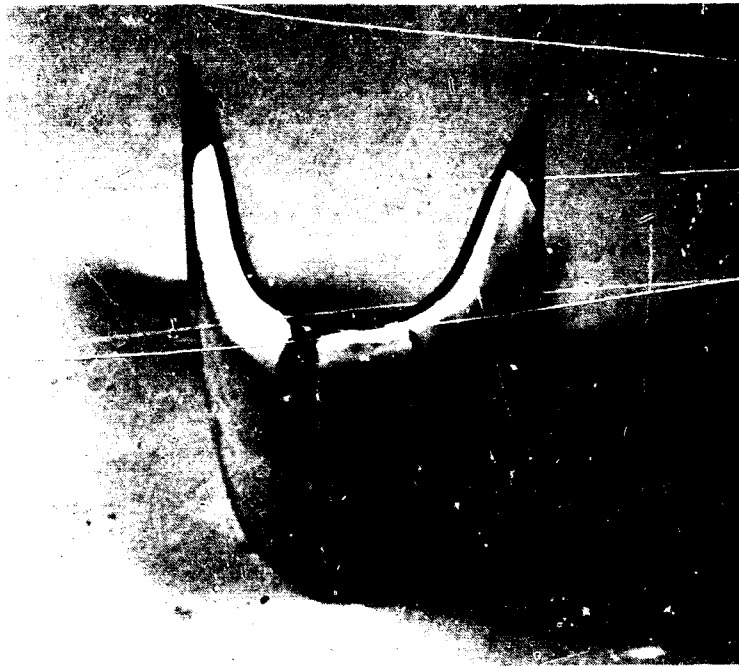
Figure 34 Typical Specimen After Bending to Evaluate Bond Strength
Between Abradable Material and Backing Plate XP-78405

(U) The bond strengths obtained between the nonmetallic and metallic materials and the backing plates were initially evaluated by bend testing. A typical bend specimen is shown in Figure 34 after testing. Final evaluation of the bond strengths were made during the static oxidation and aging tests and during the dynamic abrasion tests. Bonds were considered to be satisfactory only when all failures of the material occurred outside of the interface between the specimen and the backing plate.

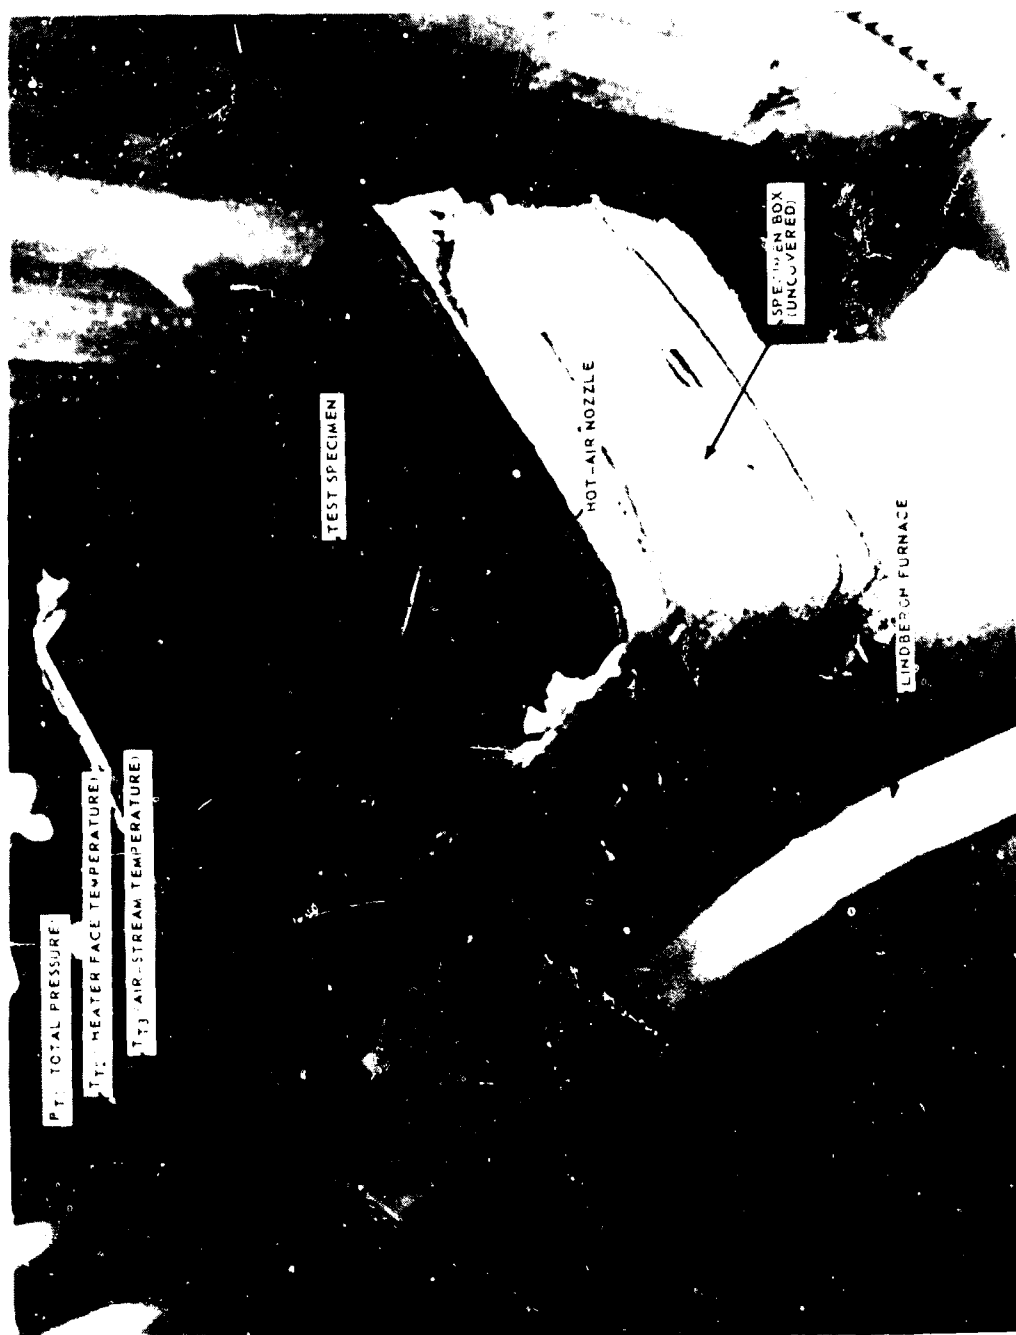
Figure 47 Hot Gas Erosion Test Equipment for Abradable Materials for
Medium-Temperature Use
N025057

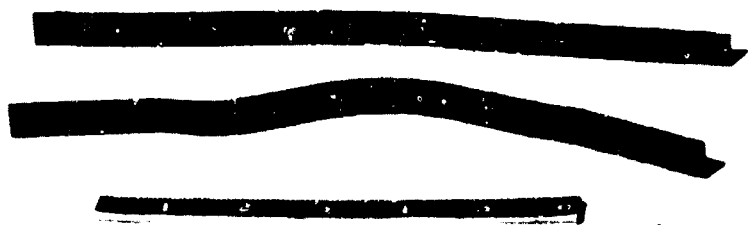
Figure 89 Normal Low-Cycle Fatigue Specimen After Failure (Top) and Hinged Specimen (Bottom)
